## The John Marsh Stone House

The Marsh House is an architectural treasure of immense historical importance. It bridges the gap between the missions, adobes and ranchos of the Mexican period and the stately mansions of the American era. The Marsh House will be the center piece of the new state historic park.

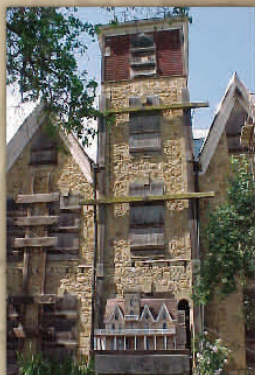
The house is 36 ft. by 60 ft. and rises 40 ft. to the ridge of the roof. The interior walls are plastered brick. This inherent geometry is largely responsible for the structural survival of the House through the one and half centuries of neglect, misuse and earthquakes.

The tower is open air with a high crenellated parapet with a 360 degree panoramic view from the delta to the foothills of Mt. Diablo. The tower was damaged after major earthquakes in 1868 and 1906. The stone was replaced by wood and shaped to emulate the damaged stone work.

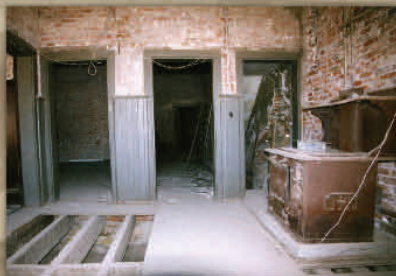
*south wall*

In recent years there have been emergency repairs of the failing stone and brickwork on three of the four walls of the house. However the south wall has collapsed and requires rebuilding for the stabilization of the house.

The John Marsh Historic Trust is now working to raise the hundreds of thousands of dollars necessary to restore the collapsed south wall of the Marsh House.
